Manhole Inspection Summary

Manhole # S69O__009MH

Insp Date: **2/6/08 10:49 AM**

Location Address: **6709 Boston Ave.**

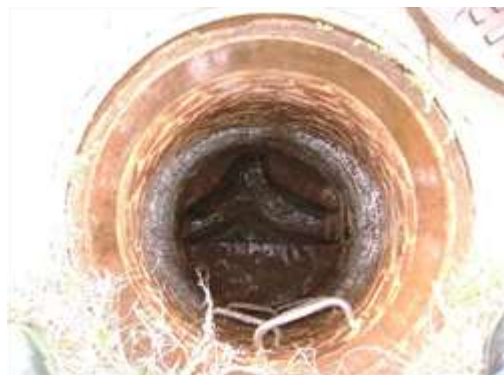
Top View

Condition: ☐ Sound ☐ Cracked ☐ Root Intrusion ☐ Deteriorated ☐ Leaks ☒ **Debris**

Count: **7** Missing: **0** ☒ **Corroded**

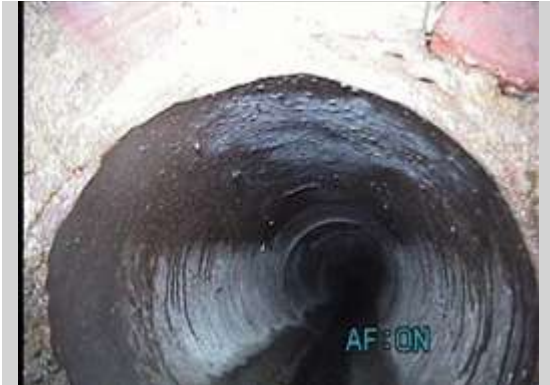
12 O'Clock Outflow

8 in. Circular Gravity Sewer
Pipe Out @ 12 O'Clock

Pipe Height: **8.4** (in.) Rod and Bar (Angled)
Pipe Material: **Clay** ☐ Pipe Lined
Invert Depth: **11.50** (ft.) Flow Characteristics: **Slow**
Deposits: ☒ None ☐ Mud ☐ Sludge ☐ Debris ☐ Grease
Silt Depth: (in.) Deposits Extent:
Infiltration: **None** Pipe Seal Cond: **Sound**

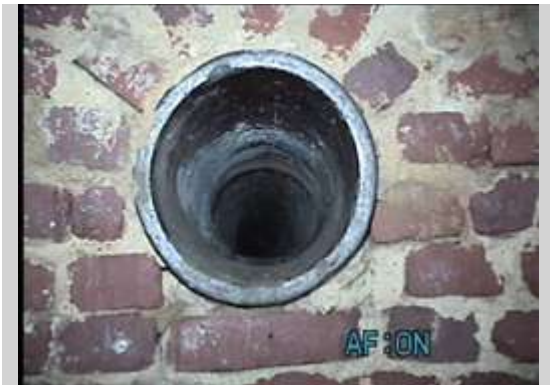
3 O'Clock Inflow

8 in. Circular Gravity Sewer
Pipe In @ 3 O'Clock

Drop In @ 3 O'Clock

Pipe Height: **8.4** (in.) Rod and Bar (Angled)
Pipe Material: **Clay** ☐ Pipe Lined
Invert Depth: **9.42** (ft.) Flow Characteristics: **Slow**
Deposits: ☐ None ☐ Mud ☐ Sludge ☐ Debris ☒ Grease
Silt Depth: **0.125** (in.) Deposits Extent: **Light**
Infiltration: **None** Pipe Seal Cond: **Sound**

Drop: **Outside** Rod and Bar
Angled: **Yes** Reading: **10.17** (ft.)
Inv Depth: **11.17** (ft.)

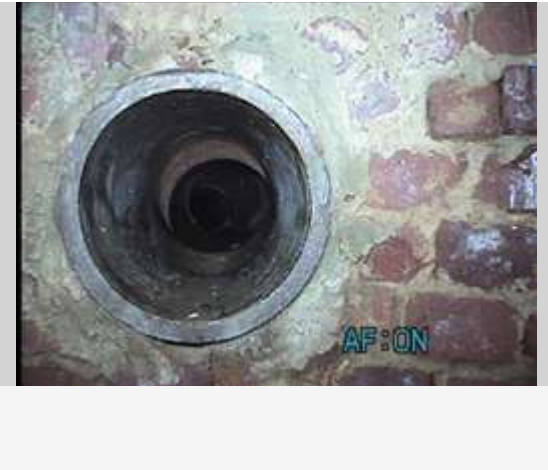
9 O'Clock Inflow

Pipe In @ 9 O'Clock

Pipe Height: **8.4** (in.) Rod and Bar (Angled)

Invert Depth: **9.17** (ft.) Flow Characteristics: **None**

Infiltration: **None**

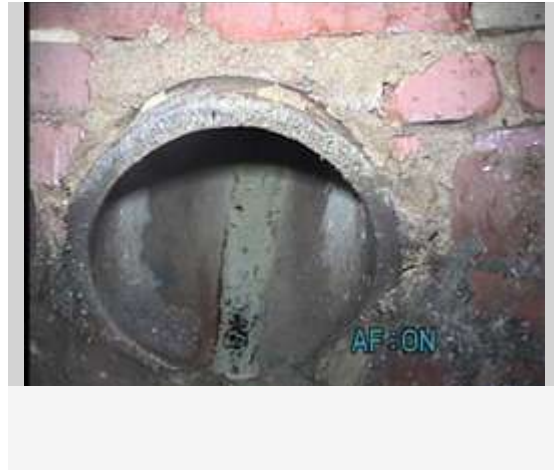
Drop In @ 9 O'Clock

Drop: Outside	Rod and Bar
Angled: Yes	Reading: 10.00 (ft.)
	Inv Depth: 11.00 (ft.)
Drop Condition: Open
